**FEASIBILITY STUDY FOR CONSTRUCTION OF ADDITIONAL  
FLOOR OVER THE EXISTING "ACADEMIC BLOCK" BUILDING  
OF NATIONAL LAW SCHOOL OF INDIA UNIVERSITY,  
NAGARABHAVI, BENGALURU**

**JULY 2011**

**The Registrar  
National Law School of India University  
Nagarabhavi, Bengaluru**

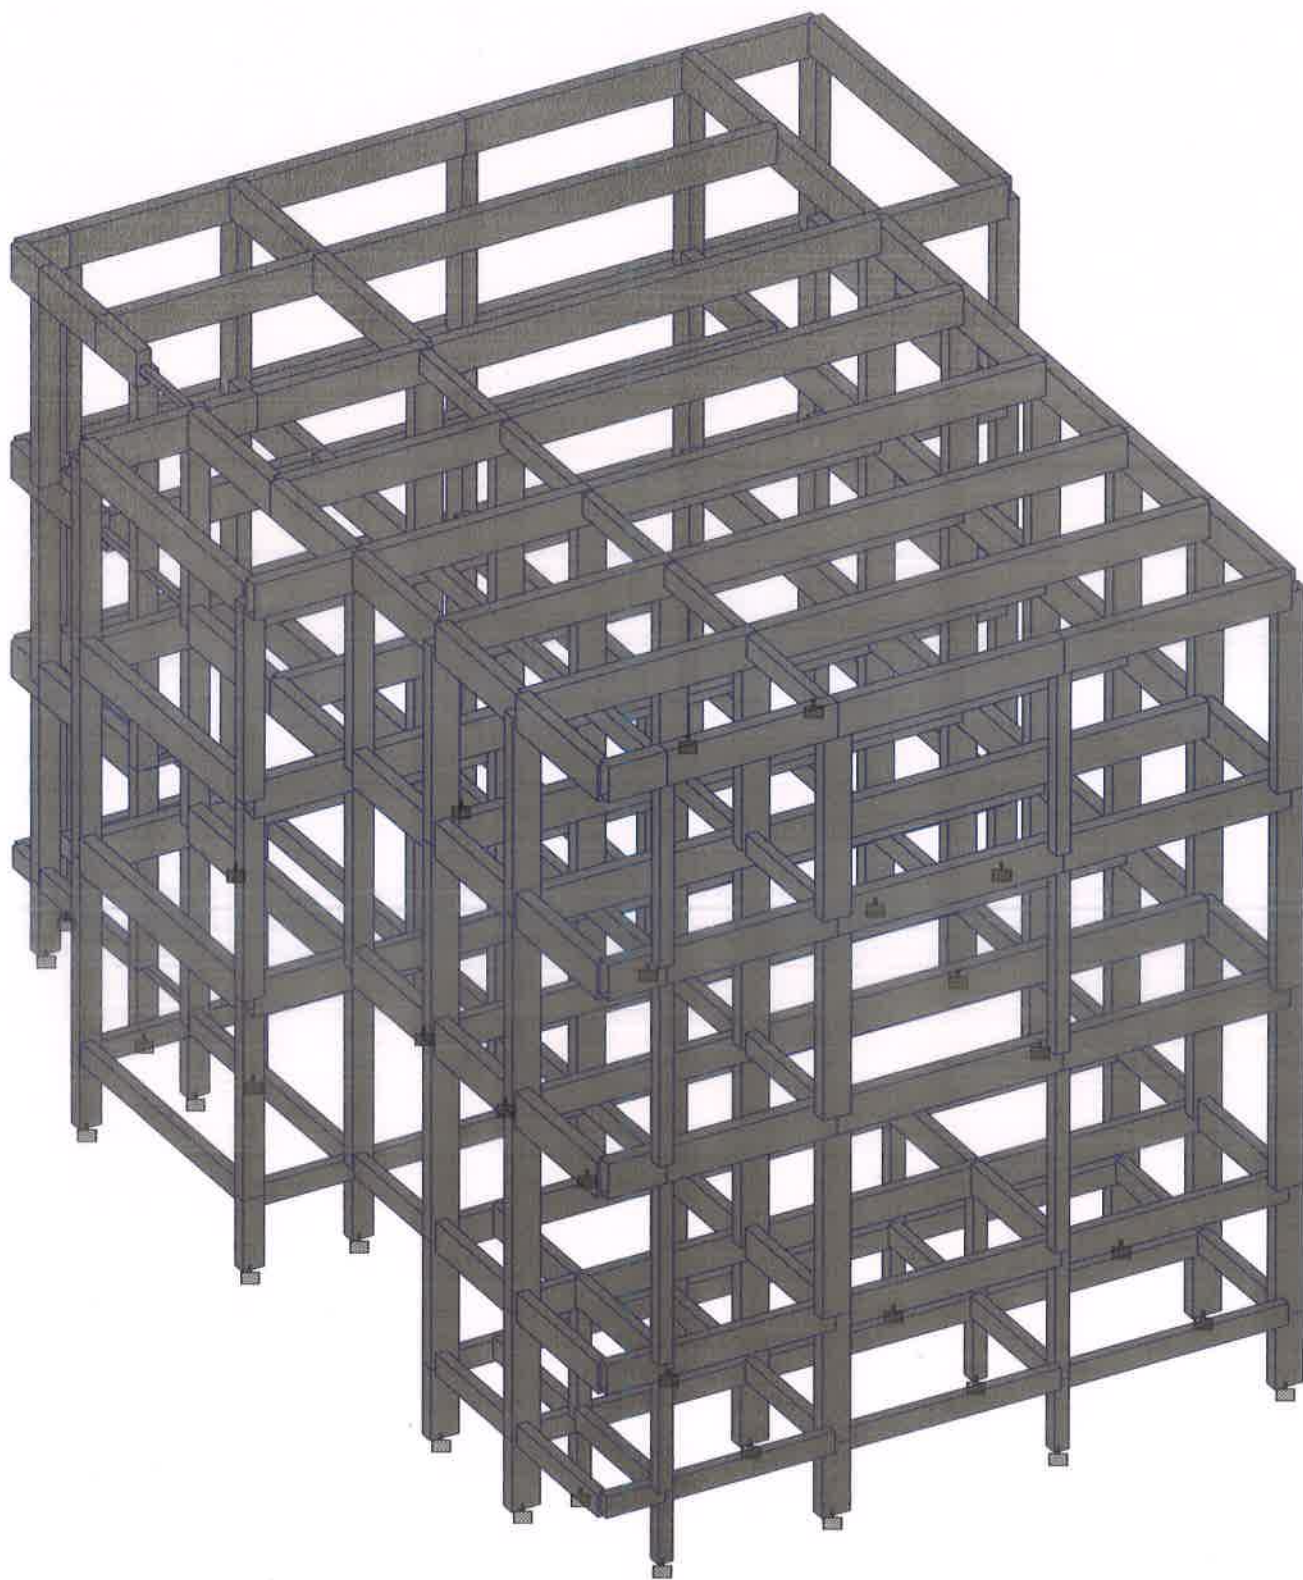
# STAAD MODELS

In addition to the above investigative tests, a detailed theoretical structural analysis was carried out for the existing structure and also for the proposed additional floor over the existing structure. The entire building is modeled in **STAAD Pro 2006** software for detailed structural analysis.

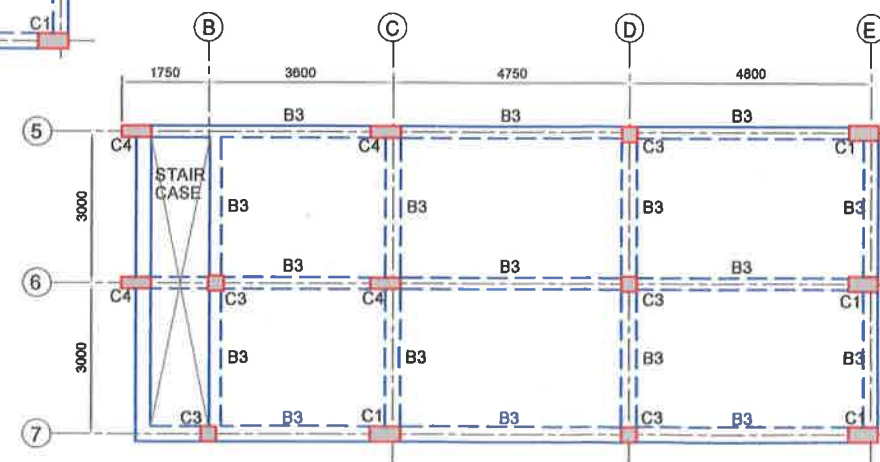
CIVIL-AID/NDT/RES-01

1. ALL DIMENSIONS ARE IN MILLIMETRES.
2. FOLLOW FIGURED DIMENSIONS ONLY.
3. COLUMNS (i) C1 - (300X800) (ii) C2 - (300X450)  
(iii) C3 - (300X300) (iv) C4 - (230X800)
4. BEAMS (i) B1 - (300X750) (ii) B2 - (230X450)  
(iii) B3 - (230X625)

### EXISTING LAYOUT OF COLUMNS & BEAMS

The dimensions of typical footings (after exposing typical column footing), masonry walls, columns, beams and slabs were physically measured and recorded for theoretical verification and preparation of layout sketch.

***(Refer sketch Civil-Aid/NDT/RES- 01)***

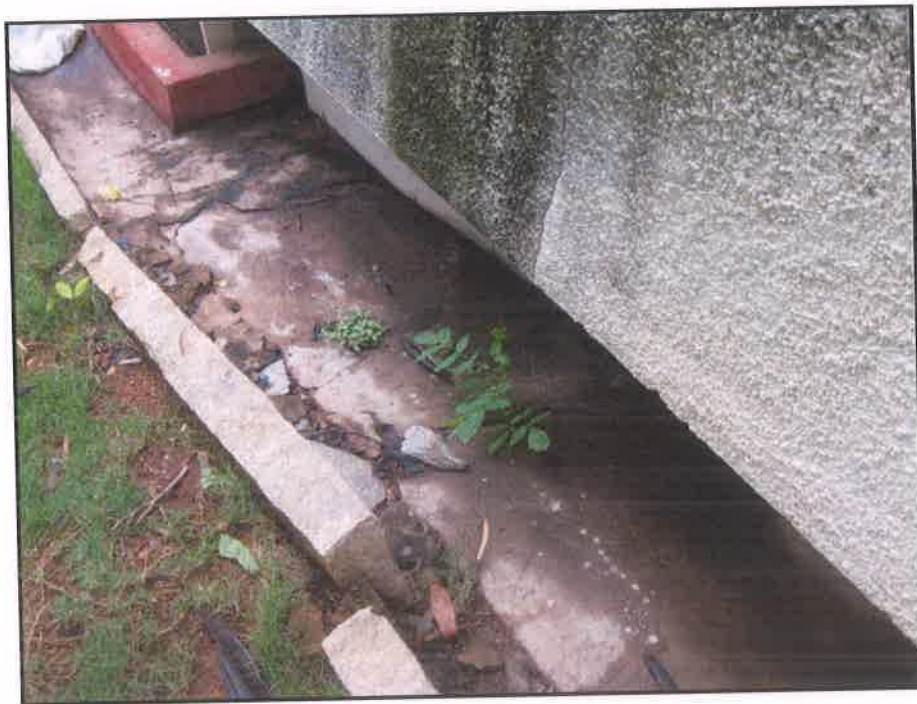
- No signs of settlement of foundation system were observed in any part of the building.
- Growth of vegetation / plantation was observed close to the building at various locations.
- Debonding of cladded tiles were observed in external masonry walls at various locations.
- Separation cracks were observed in between RC members and masonry walls at various locations / floors.
- Growth of fungus was observed in masonry walls at various locations.
- Peeling of paint was observed in masonry walls of at various locations.
- Damage of rain water outlet pipes were observed at various locations of the building.

**Growth of vegetation close to the building  
(Typical views)**

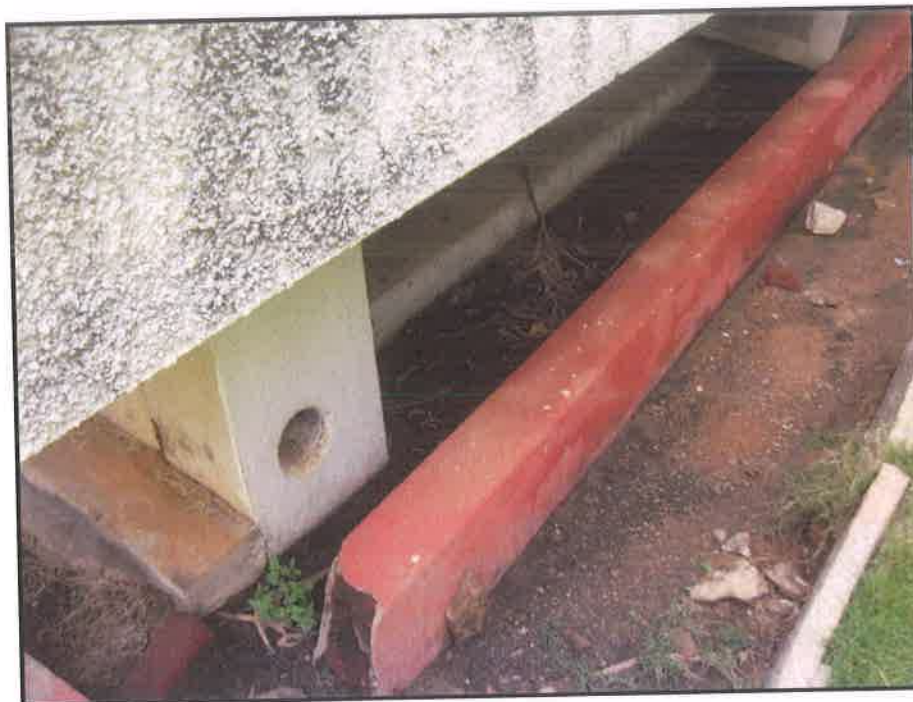
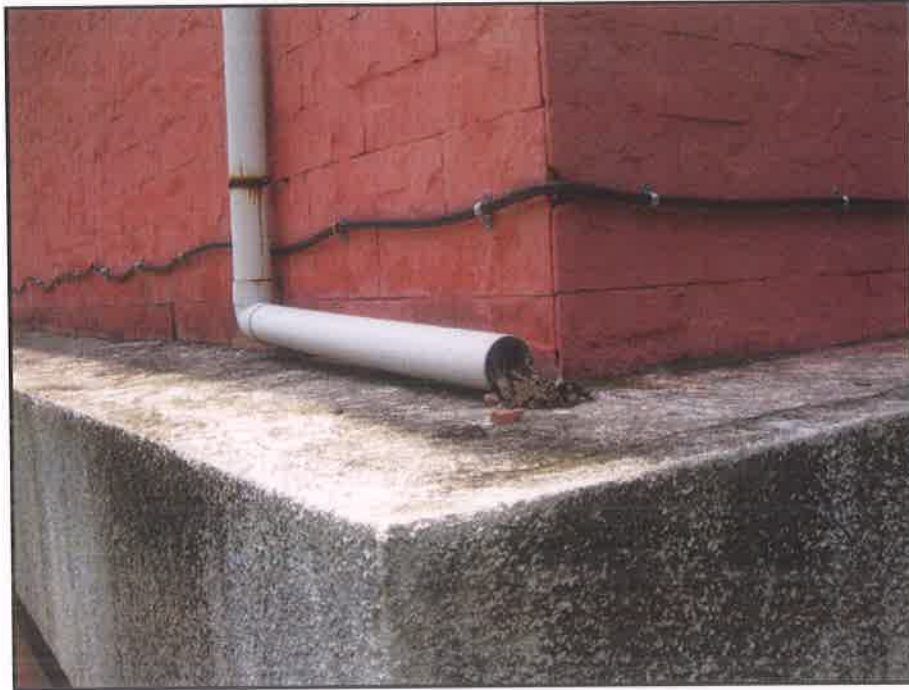
- Dampness and damp patches were observed in RC members and masonry walls at various locations of the building.
- Haphazard cracks and Accumulation of dead leaves were observed in WPC over roof slab at various locations.
- Chocking of rain water outlets over terrace was observed at various locations.

**Chocking of rain water outlet  
(Typical views)**

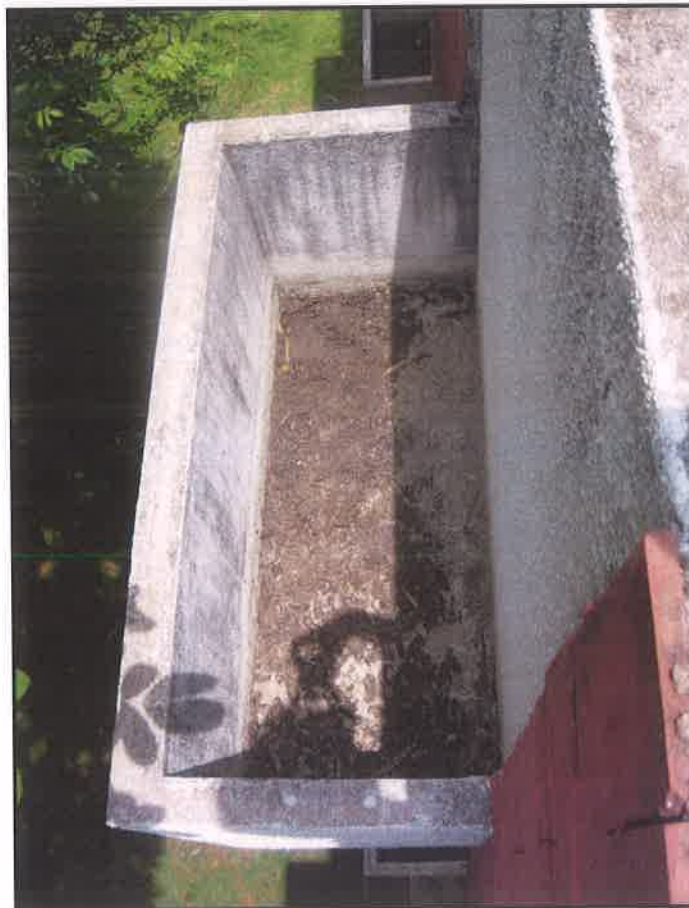
**Accumulation of waste materials over chejja**

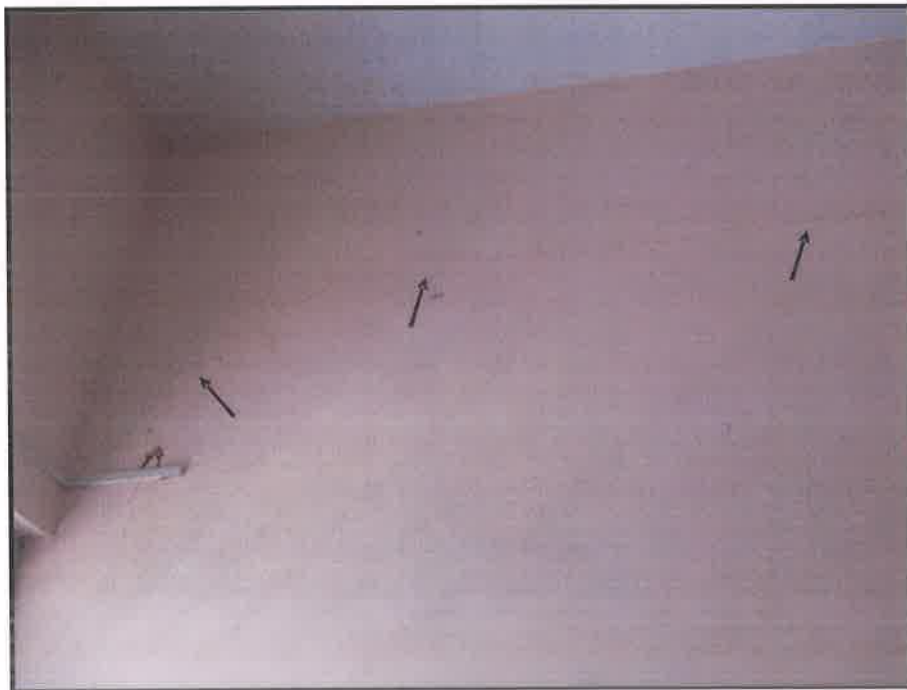
- ❖ Development of cracks at the interface of beam-wall / column-wall is mainly due to separation, shrinkage and differential thermal movement.
- ❖ From the results of Semi-Destructive test on RC footing and Non-Destructive tests on RC columns, beams and slab, it is inferred that the quality of concrete is found to be satisfactory.
- ❖ The Covermeter studies indicated that the cover concrete provided for reinforcement of RC members confirms to required standard.
- ❖ From the theoretical analysis and design verifications, it is found that the construction of one additional floor (i.e., Third floor) over the existing building is feasible.

**Separation crack between masonry wall  
and RC members**

The existing separation cracks between masonry walls and RC members shall be sealed with elastomeric crack sealant after making necessary surface preparation as per manufacturer's specification.

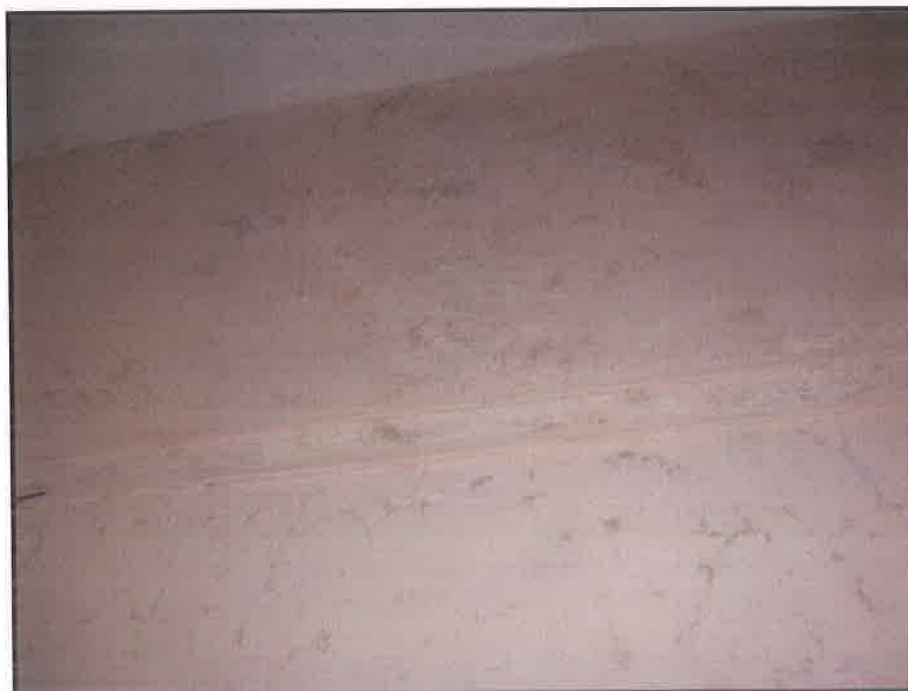
- ❖ Dampness and Damp patches were observed masonry walls are essentially due to the leakage of water from damaged / deteriorated rain water outlet pipes at various levels.

**Damp patches in masonry wall  
(Typical views)**

- a. The affected plaster due to dampness on masonry walls shall be totally removed by gentle chipping.
- b. The mortar joints in walls shall be deep raked and repointed with cement mortar 1:4 as per standard practice followed by replastering in cement mortar 1:6.
- c. All damaged / deteriorated rainwater outlet pipes shall be removed completely and replace the same with new ones as per standard practice.

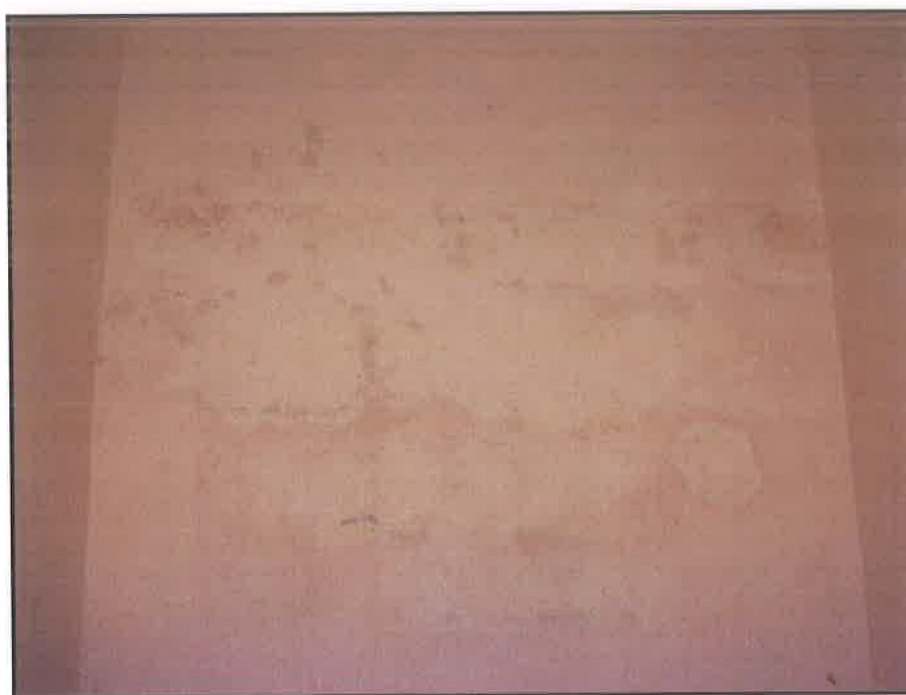
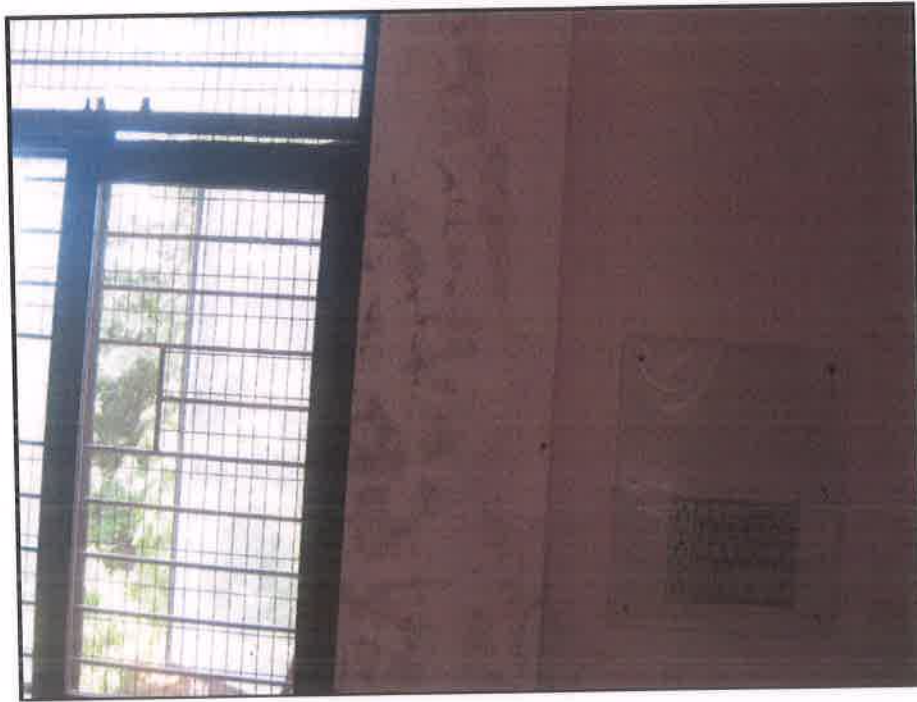
**Damp patches in RC column and ceiling slab**

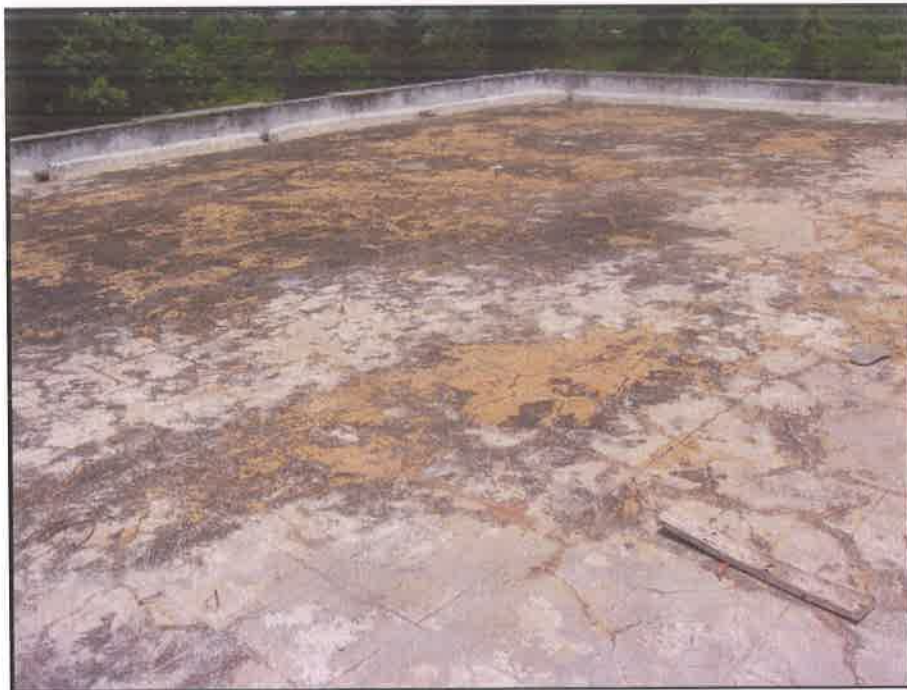
**Crack in WPC over roof slab**

- a. The loading on proposed floor shall not exceed the loading assumed for analysis and design check.
- b. The existing WPC on the terrace shall be completely removed before construction of additional floor.

- e. No structural alterations and change in loading shall be made in future in the existing building after construction of proposed additional floor.
- f. After constructing the additional floor, the exposed top surface of roof shall be provided with suitable WPC treatments for ensuring leak proof RC roof slab.

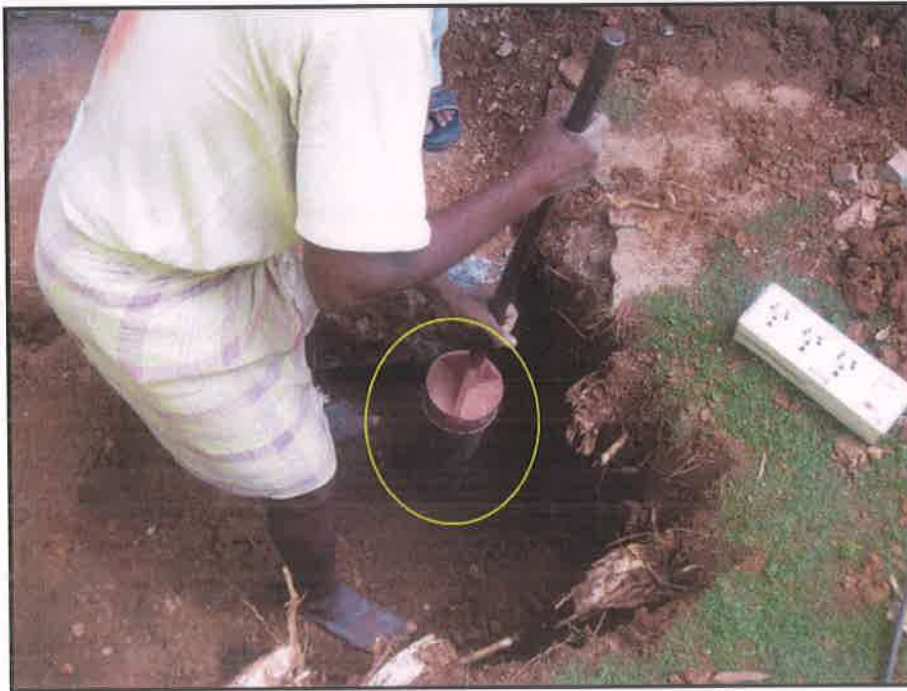
To examine the foundation system and to verify the soil characteristics below the foundation one number of trial pit was excavated up to the founding level selected at random. The soil strata encountered at the founding level consisted of soft rocky strata. Ground water table was not encountered at the founding level.

Due to encounter of rocky strata at founding level, the **safe bearing capacity** of soil is assumed as **25 t/sq.m.**

**Extraction of undisturbed soil sample  
from founding level in progress**

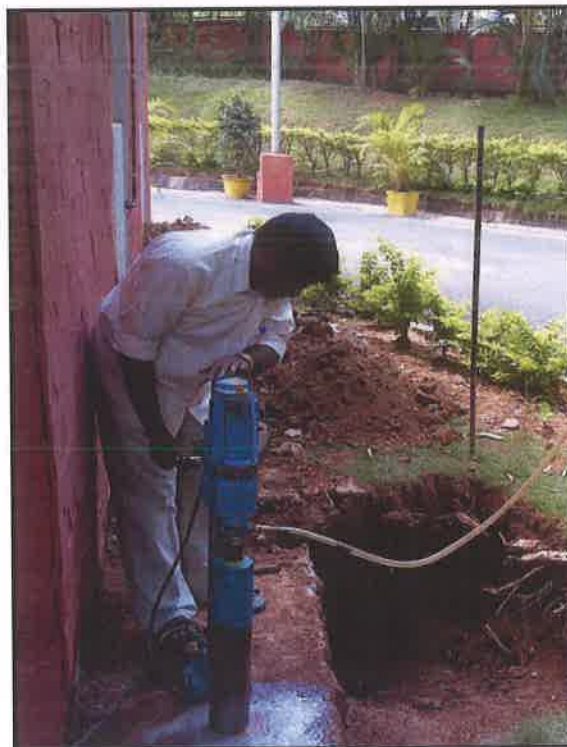
The extracted concrete cores were free from voids, honeycombs indicating good quality of concrete in RC footings. The results of concrete core tests are tabulated in **Table-1**.

The results of the tests indicate that the strength of concrete in tested cores is varying in the range of **21.9 N/sq.mm** to **22.9 N/sq.mm** in footings.

**Extraction of concrete core sample  
from footing in progress**

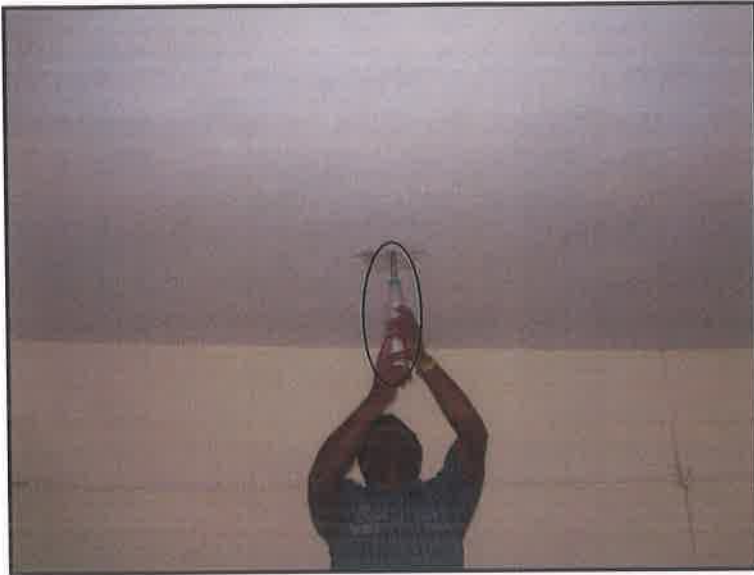
Rebound Hammer test results indicate that the estimated strength of in-situ concrete nearer to surface in tested region falls in the range of **20 N/sq.mm to 22 N/sq.mm**.

**Rebound Hammer test  
on RC slab in progress**

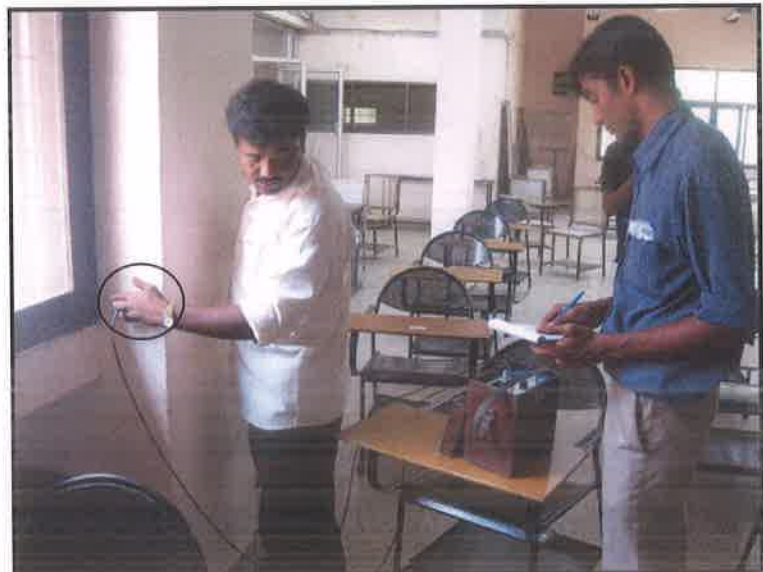
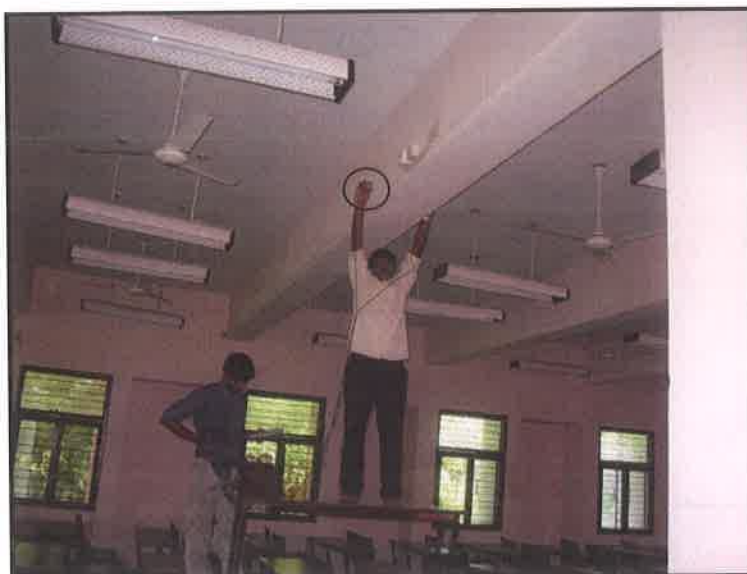
The Ultrasonic Pulse Velocity test results indicate that the quality of concrete in the tested RC columns and beams falls under the category of **"Medium to Good Concrete"** as per Table-2 of IS: 13311-(Part-I)-1992-(Reaffirmed in 2004). Further, the estimated strength of concrete falls in the range of **18 N/sq.mm to 21 N/sq.mm**.

**Ultrasonic Pulse Velocity  
test on RC members  
in progress**

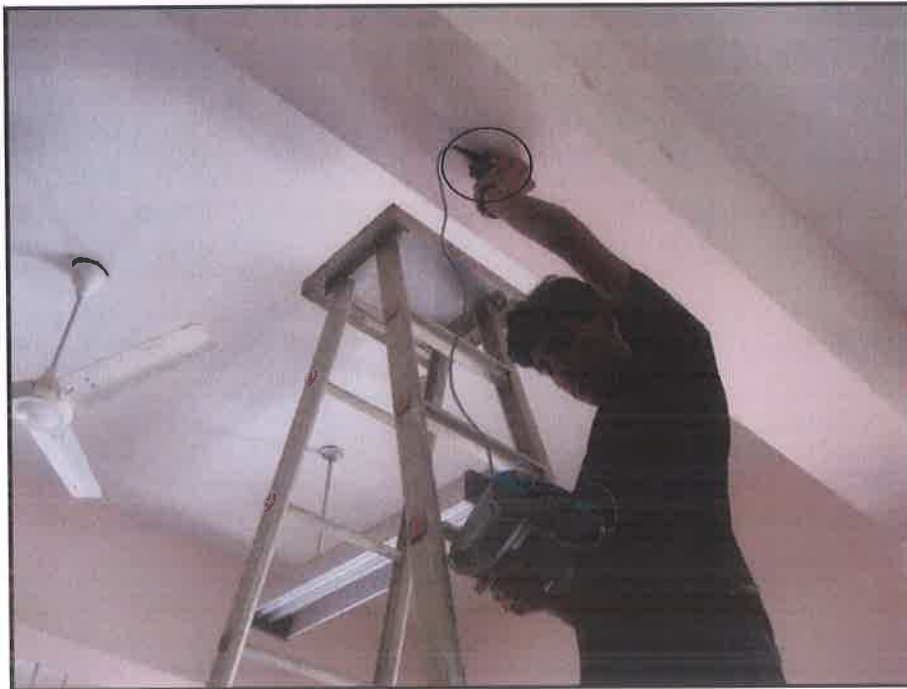
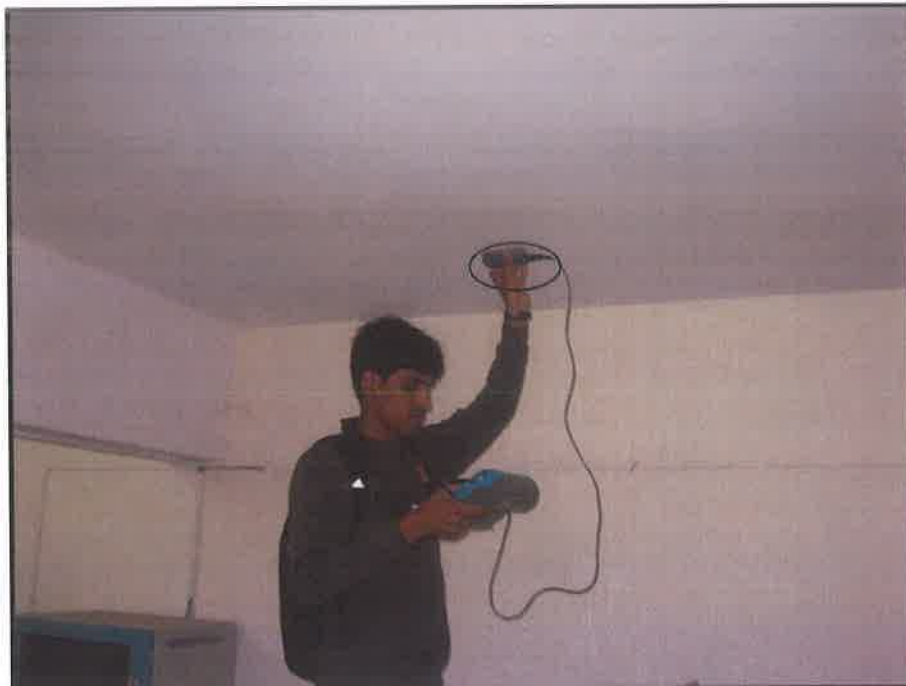
From the results of the test, it is observed that cover concrete provided to the rebars is adequate in most of the tested RC members and disposition of reinforcement is recorded for theoretical verifications.

Covermeter studies on RC members in progress
